PC1E Chamber module repair in the PHENIX Experimental Hall (bldg. 1008).

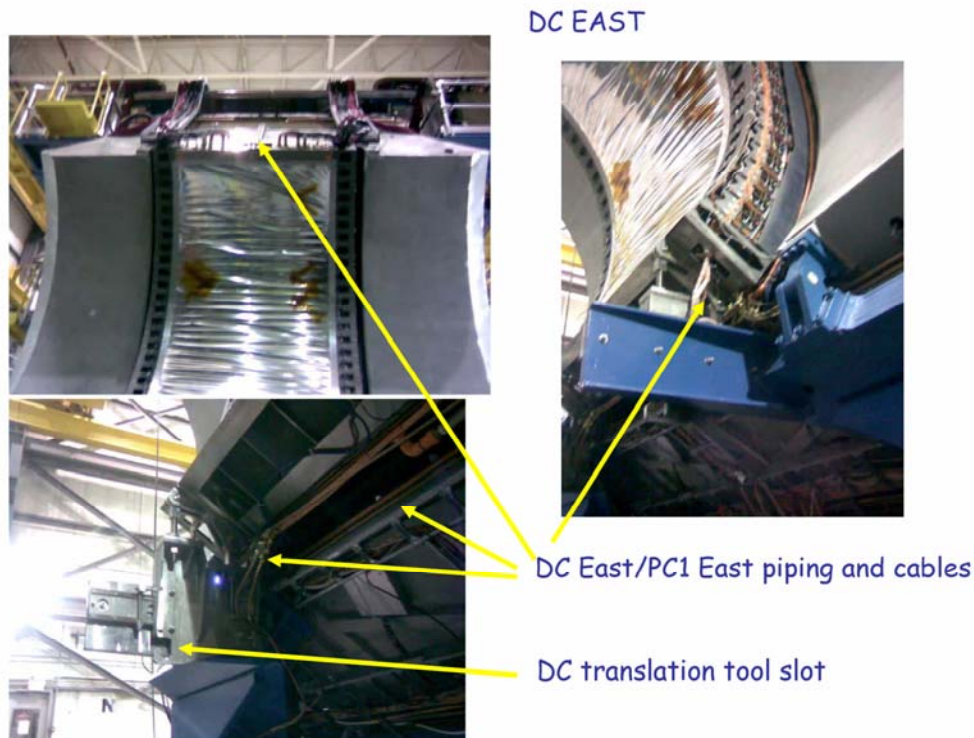
Figure 1: The DC East detector subsystem

A broken wire in the upper most Pad Chamber 1 (PC1) East chamber module of the PC detector array has been detected, necessitating the replacement of the module. A spare module has been identified and tested and found to be in good working condition. During the 2009 shutdown, while the PHENIX East Carriage (EC) is in its shutdown maintenance position, the defective module is to be replaced with the spare. Module.

Access to this module, which resides in the PHENIX East Carriage (EC) on the EC interior side of the East Drift Chamber (DC) to which the PC1 East modules are attached. (See Figure 1) Replacement of the failed module requires more access than the existing range of motion of the DC/PC1 east assembly allows in its installed configuration. Consequently PHENIX engineering has designed a fixture to extend the range of motion of this assembly and thus allow sufficient access to remove the existing defective module and replace it with the good spare while not require complete removal of the DC. The fixture has been fabricated and is ready for service.

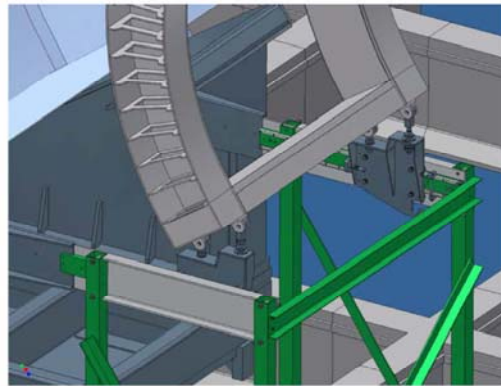
DC/PC1 in PC1 repair access position

PC1 repair tool/fixture: extends access to PC1 side of DC
